DETERMINING THE INTEGRITY OF THE FLEXIBLE BLADDER UNDER MARINE UNDERWATER CONDITIONS

BACHELOR INTEGRATION PROJECT

A marine underwater energy storage system is exposed to biofouling which causes biodegradation of the material. One of the components is made of Ethylene Propylene Diene Monomer (EPDM) on which the impacts of biodegradation regarding surface deterioration and mechanical property decrease are investigated. In this study, the extent of both impacts is investigated using experiments with a 3D Optical Profilometer and an Universal Testing Machine (UTM). The former was chosen as weighting material excludes the impact of the particles' dissolution and degradation. It is found that no corrosion occurs on EPDM and also no direct deterioration by macro-organisms is found. Mussels caused an increase in pit depth and quantity after 3 months by a maximum of 0.016 millimetre and factor 4, respectively. Calcium extraction by the mussels is deemed the most likely reason. Since an element is extracted from the compound, it is labeled as biodegradation. Surface roughness alternations of 2 to 4 micrometre were found, which could be due to ocean currents, macrofouler attachment and biot

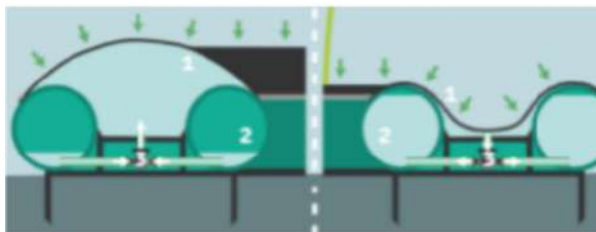
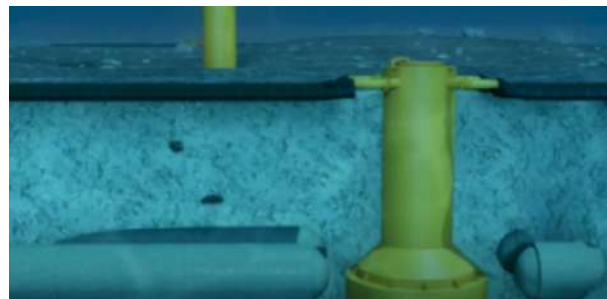
Figure 2.3: Deep-sea Design(a) and Buried Design(b) (OceanGrazer, 2021)

The design(s) of the on-site energy storage system, called the Ocean Battery Design (OBD), is depicted in figure 2.3. The design consists of three main parts: a so-called flexible bladder denoted as 1, a rigid reservoir denoted as 2 and a hydro technology system denoted as 3, as can be seen in 2.3a. The flexible bladder can get inflated and deflated with a liquid as the OBD is charged or discharged and could be compared to inflating a balloon underwater. The OBD uses residual energy from nearby Offshore Wind Farms (OWF) or integrated Wave Energy Converters (WEC) to pump a liquid out of the rigid reservoir into the flexible bladder. Due to a pressure difference between the rigid reservoirs and the pressure of the ocean, the liquid could be routed back from the flexible bladder into the rigid reservoirs with a certain speed. Energy is generated as the liquid passed through a hydro technology system along its way. Momentarily, OG has two designs, as depicted below. In the left figure the deep-sea design(>40m) is depicted and the right figure shows the buried design applicable in shallow waters(<30m). For the deep-sea design, all three components are in a box embedded on the seabed. For the buried design, the rigid reservoir and hydro technology system are in the sea ground. In this way, extra hydrostatic pressure is created due to the extra pressure deeper down and higher buoyancy pressure at greater depths. The flexible bladders will be exposed to biofouling and corrosion for both designs. The impacts of biofouling and corrosion are elaborated on in the literature study section.

(a) Deep-Sea Design

(b) Buried Design

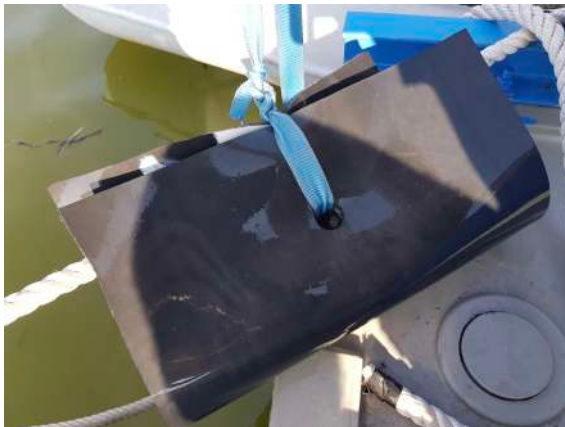
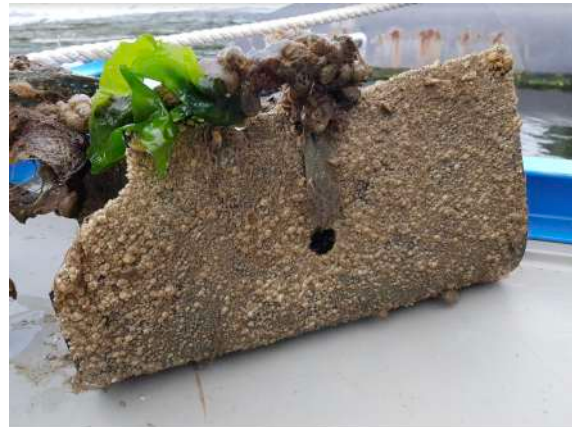
Figure 2.4: EPDM before(a) and after(b) exposure to biofouling (Van Rooij, 2021)

(a) The Piece of EPDM Before Submersion (b) The Piece of EPDM after Months of Exposure

A material under selection for the flexible bladder is EPDM, which is a polymeric material, specifically an elastomer already used in the marine sector by large companies (Van Rooij, 2021). OG has used EPDM as the material for the flexible bladder for their prototype they are experimenting with in the harbour of Groningen. Also, in June 2021, they have brought a piece of EPDM to water, intending to analyse it later when the piece is exposed to biofouling and corrosion for a certain amount of time. The figures below show EPDM before it was submerged in the harbour, and the same material after some months of exposure to biofouling. This project deals with analysing this piece of EPDM to determine the extent of biofouling and corrosion impacts.

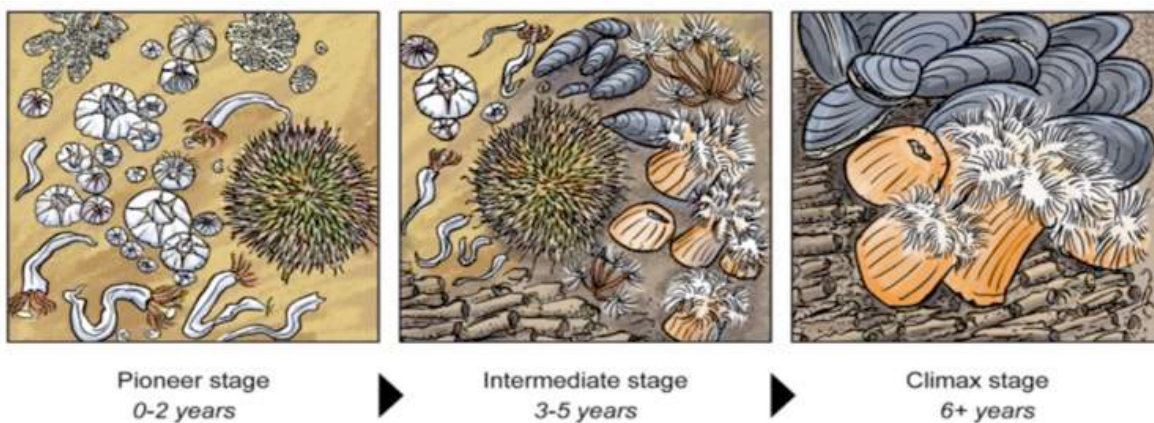
Figure 3.1: Stages Of The Biofouling Community (Canning, 2020)

There are three stages of biofouling, as is depicted in figure 3.1. The growth of the biofilm, and thus the time in which the stages develop, is dependent on some external factors including: seawater temperature, depth and light availability, currents and distance to shore, topography and wettability of the substrata, material of substrata and colour of substrata (Vinagre et al., 2020). Moreover, Kyei et al. state that salinity, conductivity, pH, and dissolved oxygen content of seawater are other external factors influencing biofouling, as well as organisms already on the substrata and the adhesion strength of organisms. These external factors are elaborated on in this section:

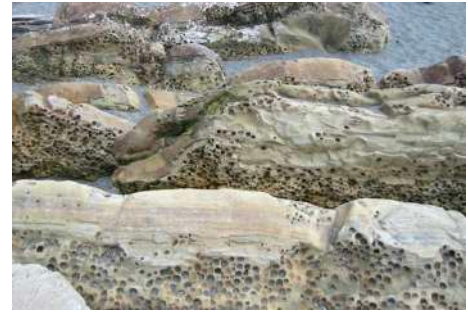
Figure 3.7: Pholad Boring (Sutton, 2022)

Furthermore, three crustaceans- species related to shrimp and lobsters; limnoriids, Sphacromatids and Chelurids, are known to deteriorate wood. Pholad and Teredine borers are found at all depths attached to all sorts of material. When larvae are born they get completely covered with bacteria over time, allowing them to settle at all materials (Vinaigre et al., 2020). These marks in figure 3.7 are from pholad boring on the east coast of North-America.

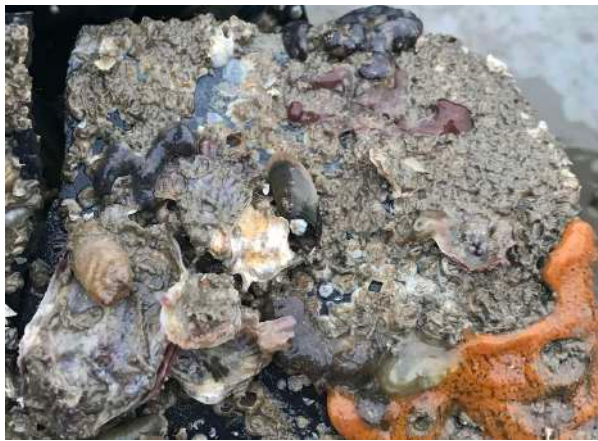
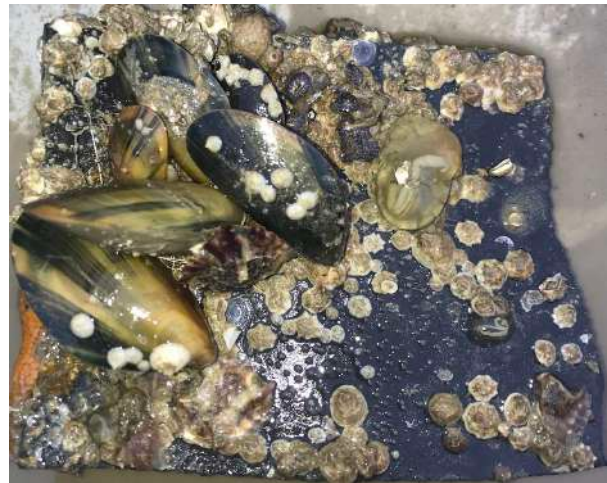
Figure 7.3: Front- and back view of the sample after six months of exposure to biofouling

A Stanley knife was used to cut samples. The sample was put in autoclaved (120 °C for 15 min) seawater in a sealed bag. Seawater filtering with an autoclave prevents any accelerated corrosion in the sealed bag. Seawater is used to keep the biofilm alive so that eventual impacts of dead animals are excluded. The number of animals are manually counted. The sample retrieved contained all macrofoulers stated in literature to directly deteriorate material. The samples retrieved include the maximum macrofouler attachment and size to observe the worst-case scenario. The sample retrieved can be seen in figure 7.3.

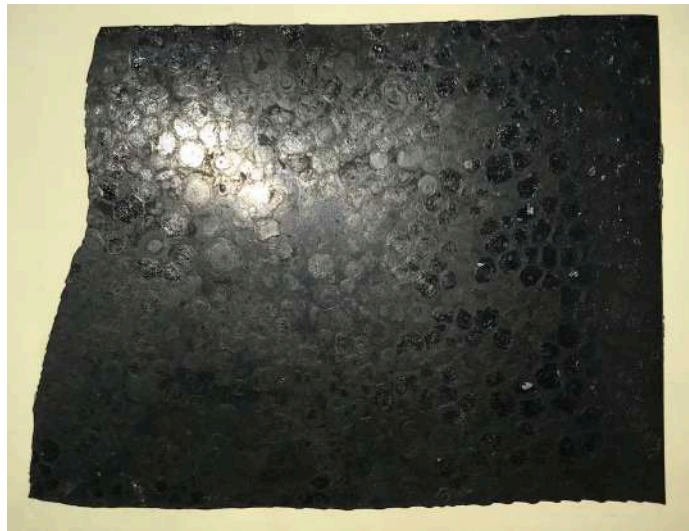
Figure 7.4: Cleaned Biofouled Sample

EPDM is highly resistant to 10% hydrochloric acid (Guide, 2021). The samples were immersed in the hydrochloric acid solution for 4 hours. The mussels were attached via byssal threads, see figure .4, which were cut and washed off with water and soft hand-scrubbing. The hydrochloric acid was washed off from the sample with plain water. A pH test was performed to check that all hydrochloric acid was removed. Once the pH was 7, the washing was deemed successful. As depicted in figure 7.4, the sample was removed from all biofouling and deemed ready for analysis.

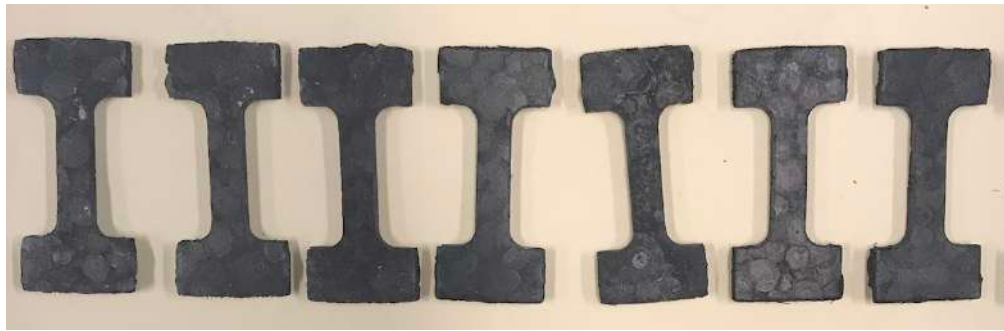
Figure 7.5: Dogbone Specimens for UTM

For the Universal Testing Machine experiments, the UG had two dogbone specimen sizes to Die Press. One sized 3 by 1 centimetre was chosen to ensure that enough repetitions could be done. In figure 7.5, the dogbone specimens can be seen. The other size is 15 by 3 centimetres, which does not allow for many repetitions, and would have been a waste of valuable harbour material which can be used over time to study the effects of biodeterioration.

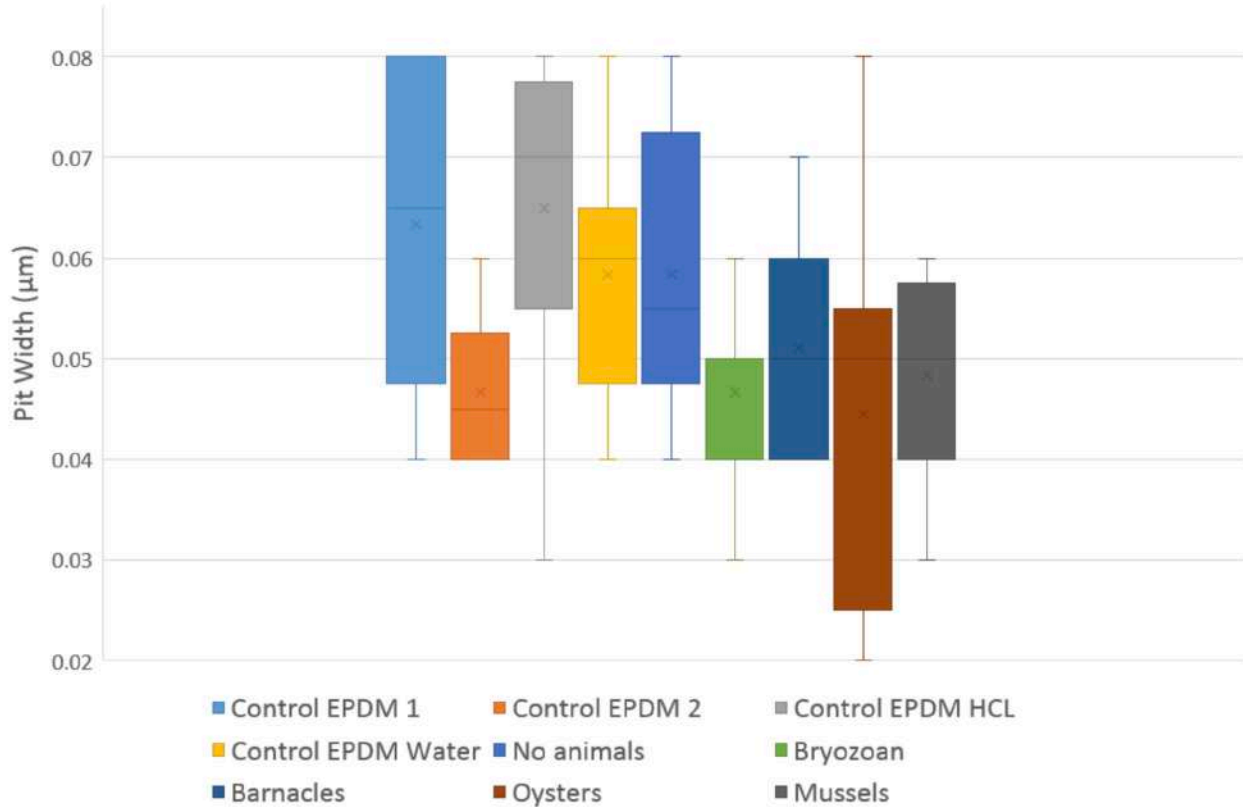
Figure 8.2: Pit width, $Rh_i[\mu\text{m}]$ for the control- and biofouled samples

A box plot for the pit width is shown in figure 8.2. The pit width of all biofouled samples did not increase compared to the control samples. This indicates that no biodeterioration has taken place on all biofouled samples.

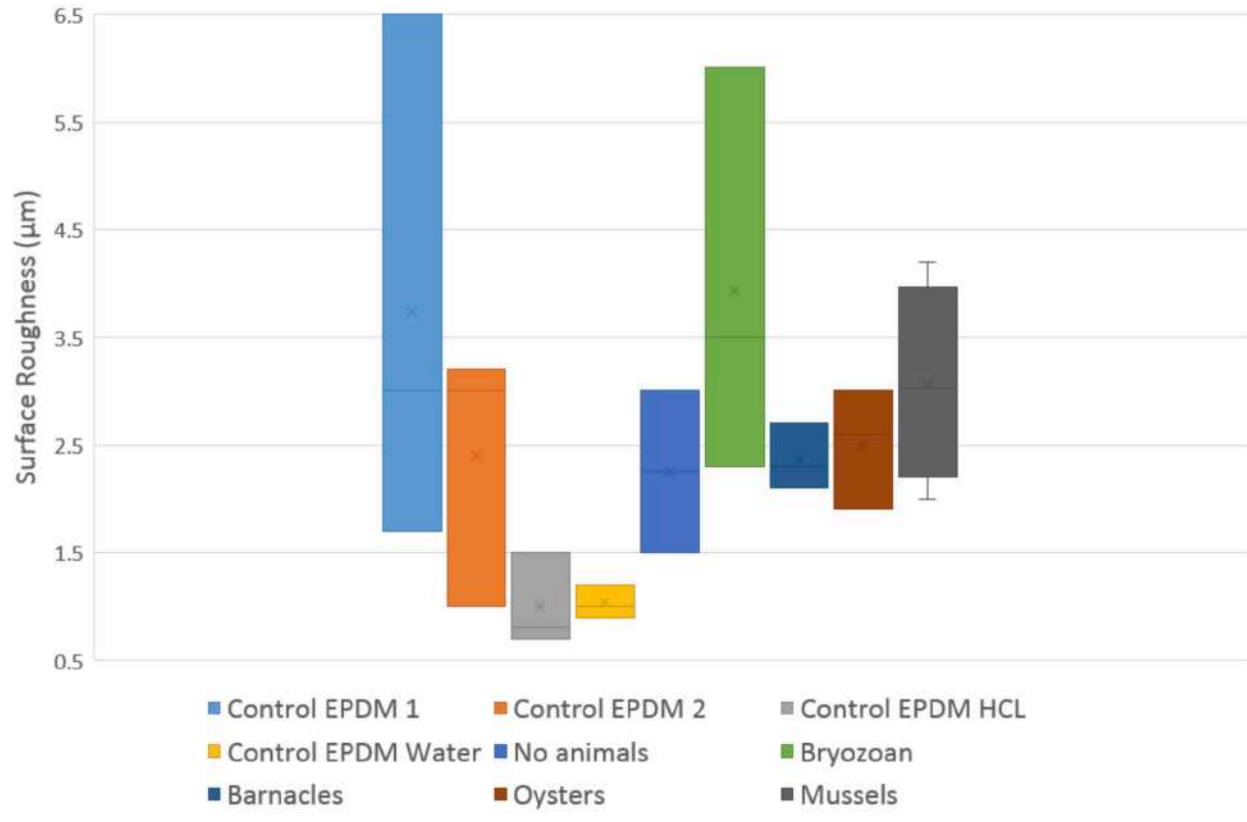
Figure 8.3: Surface roughness, $Ra[\mu m]$ for the control- and biofouled samples

The surface roughness of Control EPDM 1 & 2 were unexpectedly high. Possibly due to contamination, as the control sample had been laying around the workplace and was used for earlier experiments. Profilometers working via light direction techniques could end up measuring these surface contaminants (Ingole et al., 2013). The in-water immersed control sample showed a significant decrease in surface roughness after 4 hours of immersion. It is expected that the surface roughness further decreases more after more prolonged immersion. Moreover, this suspicion is partly based on the observation that a white substance gave the Control EPDM a white tint, which reduced significantly after immersion. Another reason could be that the "auto-level" function tool of the Proscan 2000 was forgotten to be applied before retrieving the surface roughness. One target area namely showed a significant different value of 6.5 micrometres compared to the average of 3 micrometres for the other target areas. Therefore, the surface roughness reference is deemed unreliable. Instead, as a reference for the initial surface roughness value, 0.25 micrometres is taken (Adam et al., 2019). The surface roughness increased on average by two micrometres for no animals, barnacles, oysters and

mussels, and by up to four micrometers for bryozoans. This result indicates biodeterioration and is discussed in section 9.

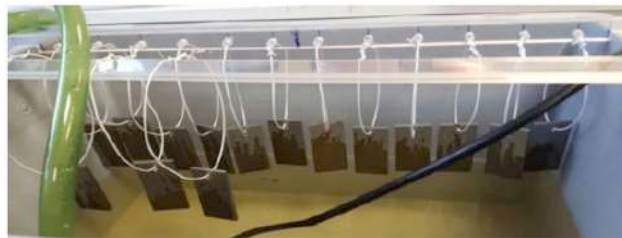
Figure .6: Coupon Testing Set-Up (Canning, 2020)

For coupon testing, coupons of the material are put in a polyethylene or glass chamber along with nutrient-enriched seawater. The temperature in such chambers could be altered to see material endurance at different temperatures. The set-up of such an experiment can be seen in figure .6.

The drawback of this method is that it solely looks at the effect of corrosion on a material, as the nutrient-enriched seawater includes micro-organisms but no macro-organisms, and therefore the effect of macrodeterioration is excluded. This method is therefore not be used for this project.
