Effect of impact energy on the formation of micro-cracks on healthy bovine cartilage

University Medical Center Groningen – Orthopaedics Department

INTERNSHIP REPORT

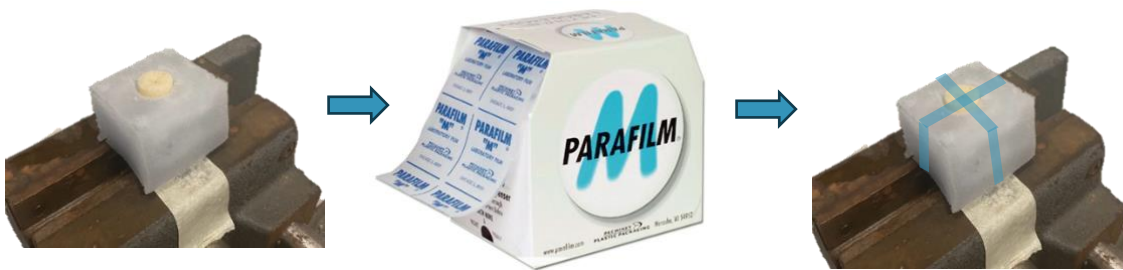
Figure 3 The two plugs are placed on top of each other, and a sponge cube surrounds them. Parafilm strips keep the whole structure together. Thin blue lines represent the PARAFILM strips

After the preparation of the plugs, one of them was placed in a steel base, that would keep it stable (**Fig. 2b**). The second cartilage plug was placed on top of it, and it was fixated using a case made from a highly absorbent sponge. The sponge was cut into cubes, and then using the same drill that was used for the plug preparation, holes were cut into the cubes, so the plugs would perfectly fit. The sponge was soaked in PBS buffer, providing constant hydration and lubrication between the two cartilage surfaces. Finally, narrow strips of PARAFILM were used to keep the entire structure together, over the sponge (**Fig. 3**).

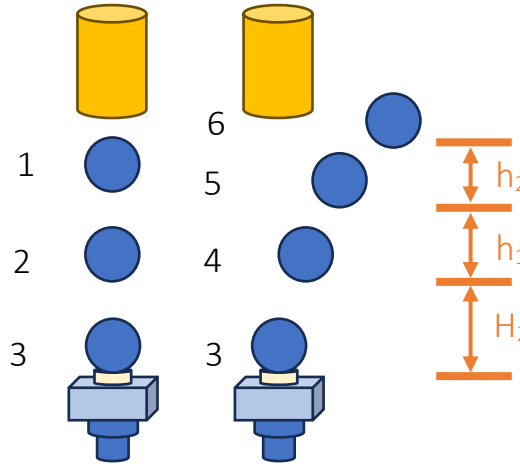
Figure 4 The falling and rebounding of the steel ball during the impact test

rebound, a camera was used (iPhone 11, Apple Inc., USA) (**Fig. 5**), in slow motion mode. After the recording of the ball motion, the following formulas were used to calculate the absorbed by the cartilage energy (E_a), by using the rebounding heights H_2 , h_1 , and h_2 (**Fig. 4**), in the same time interval (t).
